Maryland Historical Trust HISTORIC PROPERTIES
State Historic Sites Inventory Form

Survey No. B-4369

1. Name	6. 1.					
1. Name	(indicate pre					
historic	706 North	Howard Street				
and/or common	Jamgotch C	o. Oriental Ru	gs			
2. Locati	on				ăl	
street & number	706 N. How	ard Street	.1	n	ot for public	
city, town	Baltimore	vicinity of	congressional dis		Seventh	
state	Maryland	county	Baltin	nore

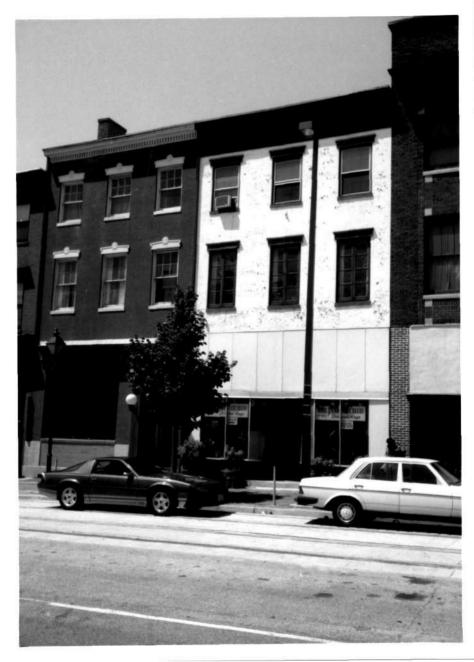
B-4369
706 N Howard St
Baltimore MD
Diane Shaw
8/91
Maryland SHPO
Facade east elevation, plus
flanking buildings
1/2

This circa 1850 building is part of a double house attached to 704 N. Howard Street to the south, and it has a partywall neighbor to the north. It is three stories tall and three bays wide. The pressed brick is laid in stretcher bond with thin mortar joints. This Italianate building has a late Art Deco first floor facade. The street frontage is 23' and the depth 150'.

The cornice is the same as its attached neighbor. It projects slightly and has a back band, an ogee profile molding below, and a dentil course. A five-string course of bricks projects below the cornice as well. Unlike 704 N. Howard, a second band of projecting bricks runs underneath the first.

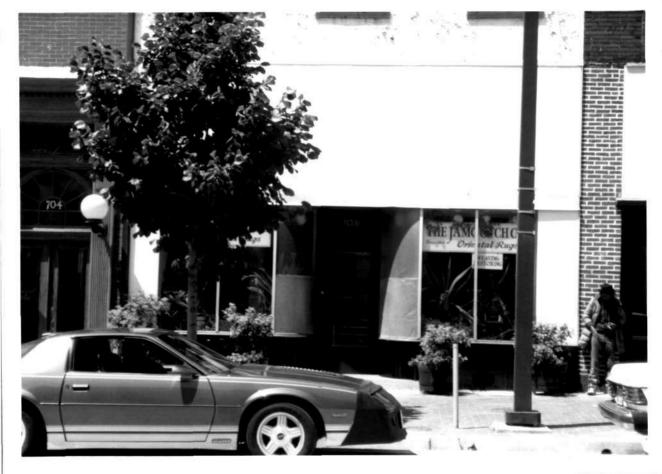
B-4369 706 N Howard St. Baltimore, MD Drane Shaw 8/91 Maryland 5480 Facade detail 2/2

The facade of the first story was substantially altered circa 1930-1940 into a vitrolite-clad storefront. A horizontal band of plate glass windows are set off with black vitrolite panels below and white vitrolite panels above. The centered, recessed glass door has rounded bullnose corners. The Moderne sweep of the entrance and the use of vitrolite point to a circa 1930s date.

into a large glass window wall. The recessed entrance is a common feature to this period; the recess permits additional display caseson either side of the vestibule. The black and white vitrolite panels are typical of the streamlined phase of Art Deco design where the emphasis is on reflective, smooth wall surfaces and simple geometric shapes. This facade is particularly noteworthy because of the streamlined, bullnose corners of the entrance.
